ISSUE NO. : 10-001

DATE : 8th January. 2010

SUBJECT	CAUTION TO THROTTLE BODY REPAIR.
MODEL	GT(R),GV - 250/650, MS3-250(D)
EFFECTIVE F/M NO	ALL FI MODEL

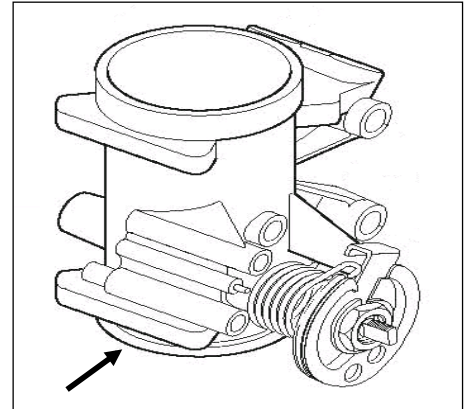
Wrong repair at Throttle body or Cylinder head could cause serious problem.

- ▷ Intake pipe would be separated by vibration and strange sound such as leaking of air appears.
- ▷ Unstable mixing condition by abnormal throttle operation could cause backfire phenomenon and there is small possibility of fire.

Must confirm that inside diameter part of intake pipe is assembled perfectly to groove of throttle body when you re-install cylinder head or throttle body. And then, do clamping.

Before clamping intake pipe, must shake it to check whether it is assembled exactly.
This notice is only for service information. So, there is no special trouble code and FRT.
